FULL SCALE TECHNOLOGY DEMONSTRATION OF A MODERN COUNTERROTATING UNDUCTED FAN ENGINE CONCEPT

ENGINE TEST

December 1987

by
GE Aircraft Engines
GE36 Project Department
Cincinnati, Ohio 45215

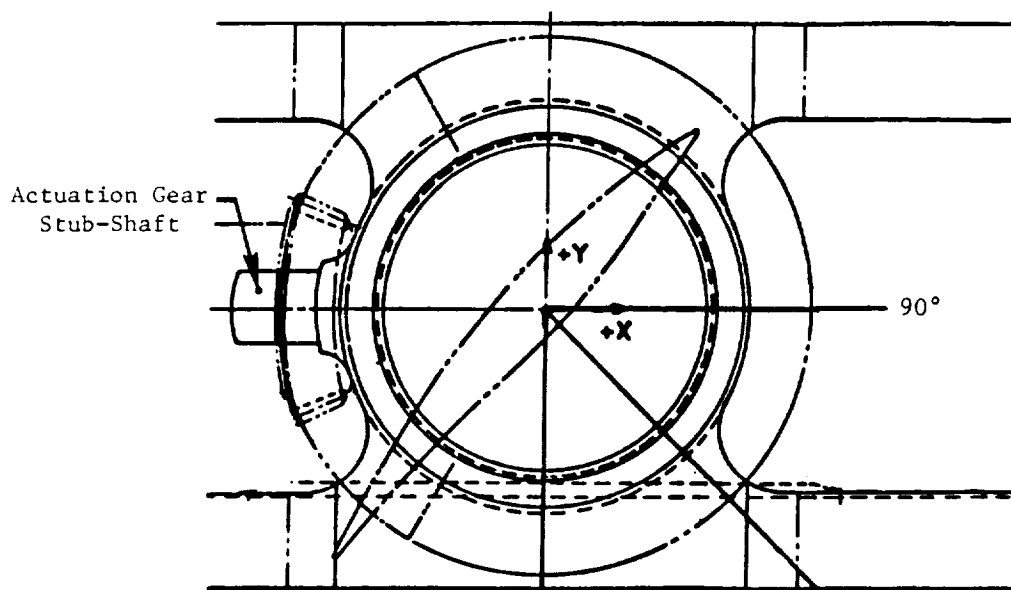
Figure 6-6. Bearing Housing Deflection.

The roller wear paths on the raceway of the cup and cone showed evidence of bearing distortion due to the unsymmetrical loads caused by the housings deflecting, as was predicted by finite element analysis. The bearing cone had been made more flexible to compensate; however, even the cone bending was not enough to provide an even loading. Deflection analysis was performed using a lighter blade weight than we currently have (Figures 6-6 and 6-7).
